CONFIDENTIAL INSPECTION REPORT

1234 Harmony Lane, Buckeye, AZ 85396

5/28/2007 8:00 am

Report File: 20070500-0000web

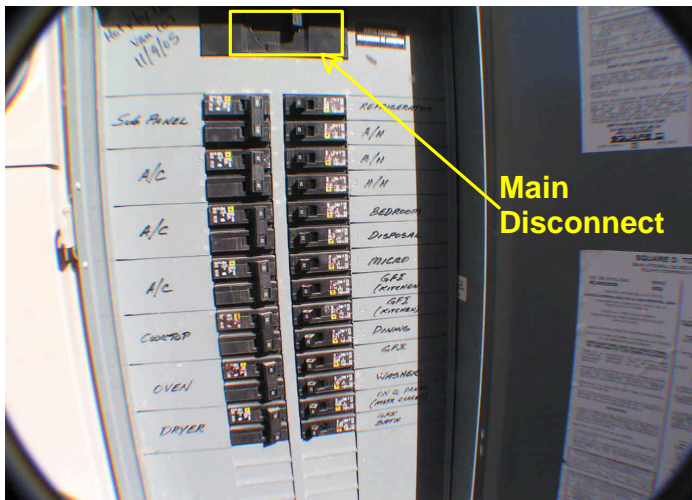
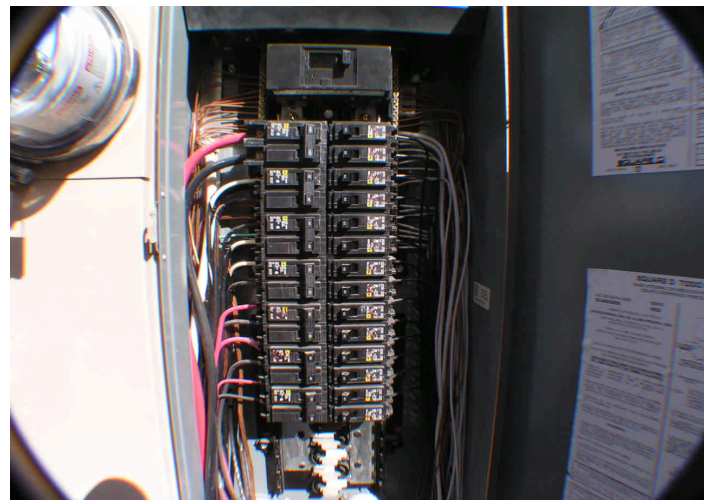
6.1 - National safety standards require electrical panels to be weatherproof, readily accessible, and have a minimum of thirty-six inches of clear space in front of them for service. Also, they should have a main disconnect, and each circuit within the panel should be clearly labeled. Industry standards only require us to test a representative number of accessible switches, receptacles, and light fixtures. However, we attempt to test every one that is unobstructed, but if a residence is furnished we will obviously not be able to test each one.

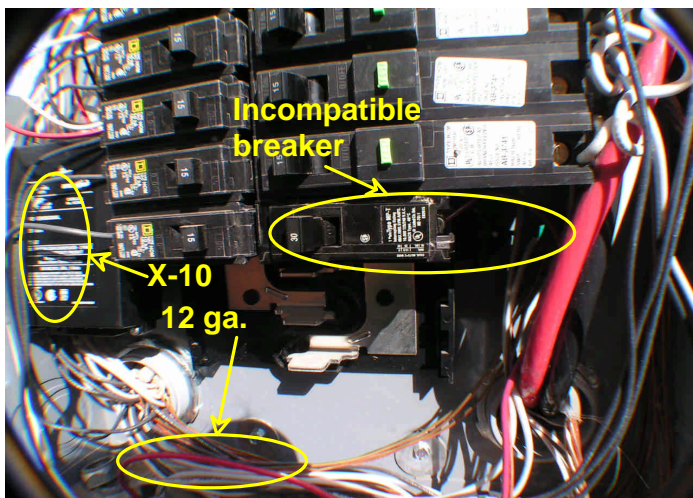
6.5 - There are no visible deficiencies with the circuit breakers and they are properly sized according to the wire capacity except one 30 amp breaker from another manufacturer is incompatible with this panel. It is connected to an undersized 12 gauge wire which could become overloaded and is a fire hazard. This needs evaluation and correction by a qualified professional.

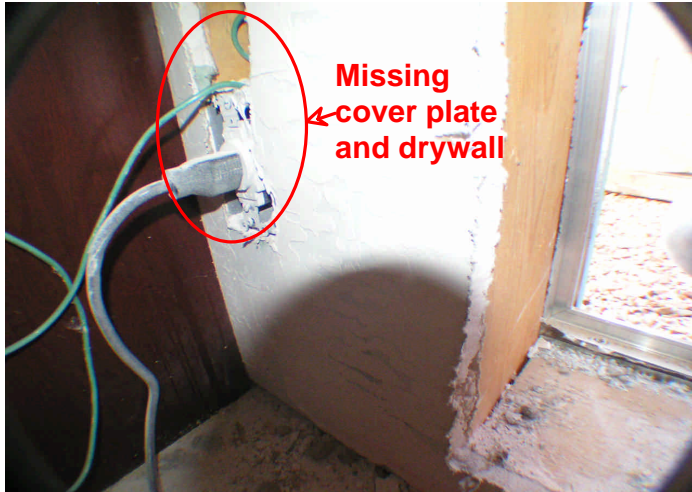
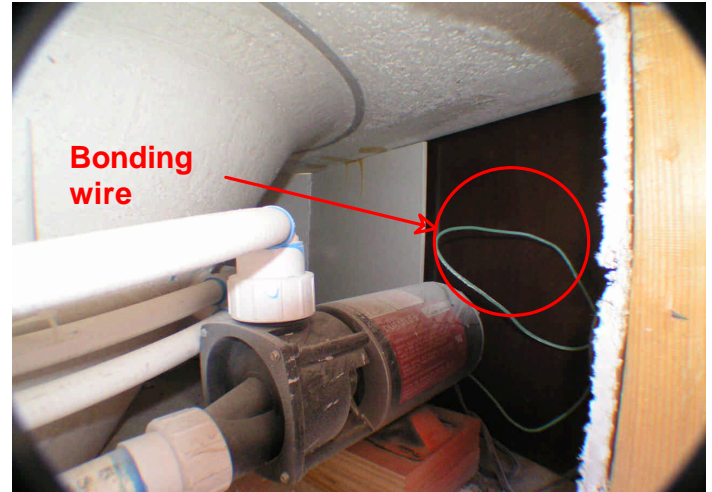
6.11 - An outlet in the jacuzzi access panel is missing the cover plate. The outlet is on the interior side of the exterior wall and is only visible from the exterior access port and with a mirror. Also the bonding wire to the jacuzzi pump needs securing. Both issues need evaluation and correction by a qualified professional.

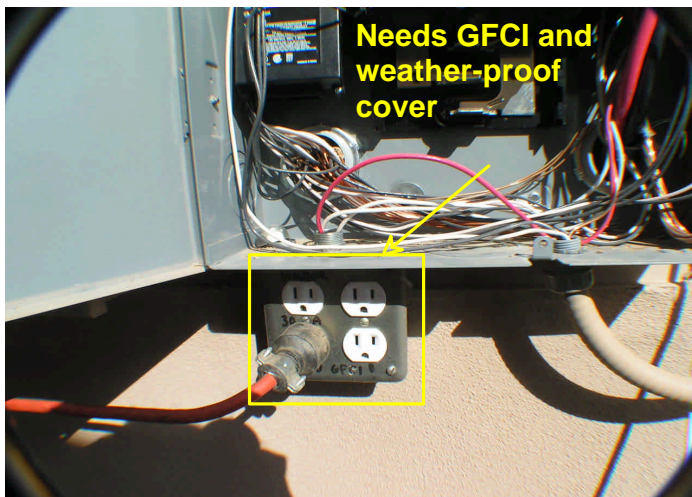
6.12 - An outlet under the panel is not weather proofed or ground-fault protected as required by current standards. This needs evaluation and correction by a qualified professional.

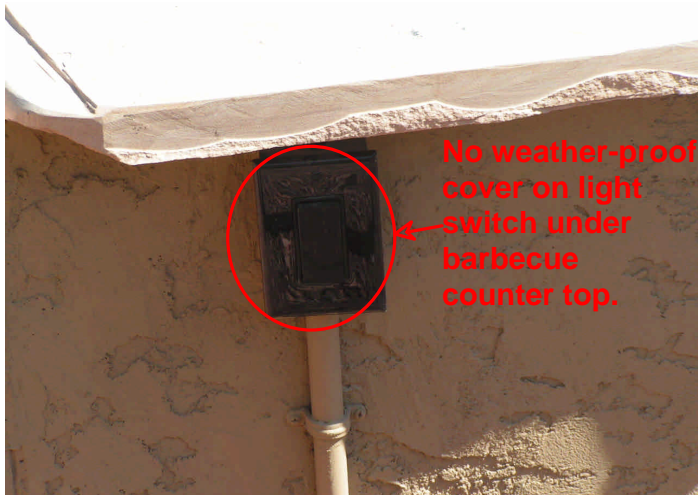
6.13 - A switch behind the barbecue is not weather-proofed and is a safety hazard. This should be replaced with a switch with a weather proof cover.

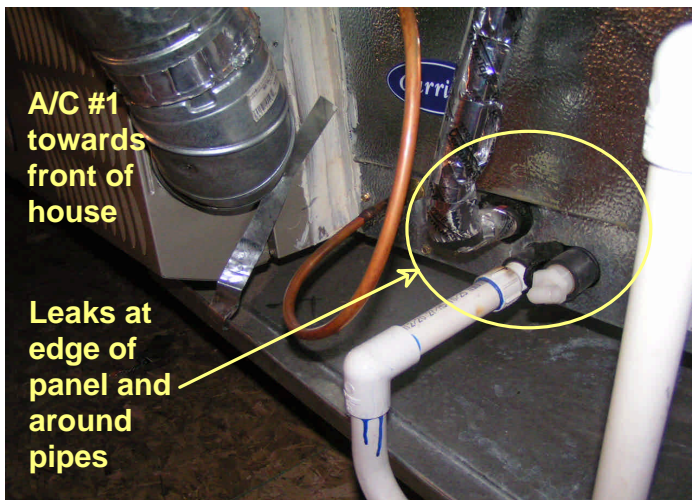
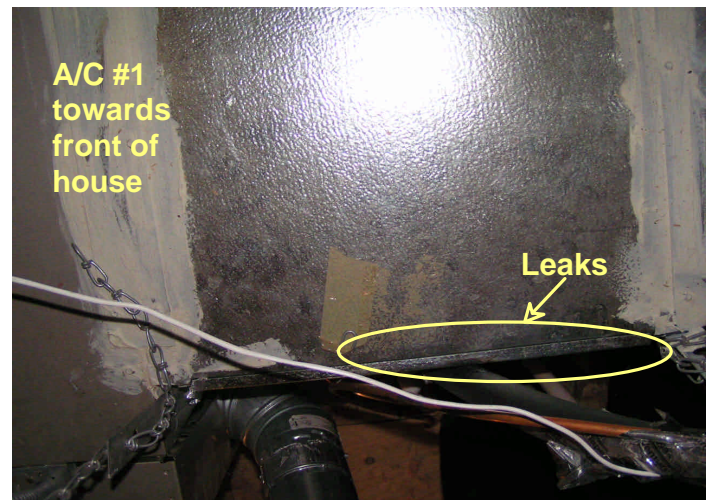
8.4 - The furnace - air handlers leak a significant amount of cold air into the attic. The temperature in the vicinity of the air handlers is 107. The rest of the attic at the same height is 113 or above. Cold air is blowing out from the vicinity of the condensate drain pipes, the evaporator access panel sides and around

the plenum/supply duct connection. This problem was observed in other similar residences with installations by the same a/c contractor.

8.2 - For the reasons indicated, the split-system needs to be serviced. This service should be scheduled within the inspection period, because a specialist might reveal additional defects or recommend upgrades that could affect your evaluation of the systems.

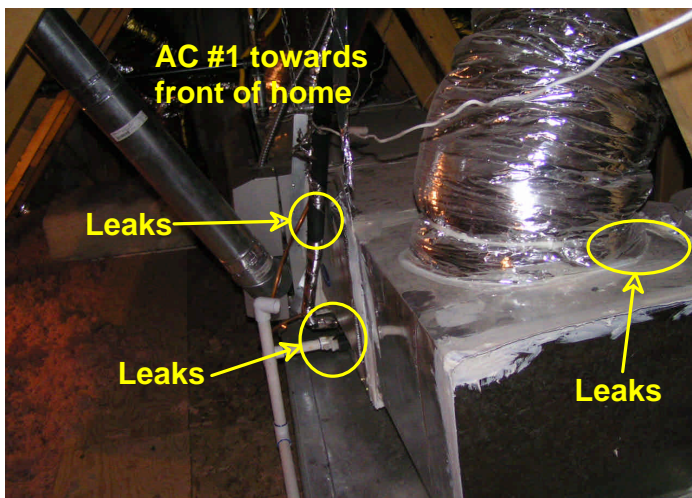
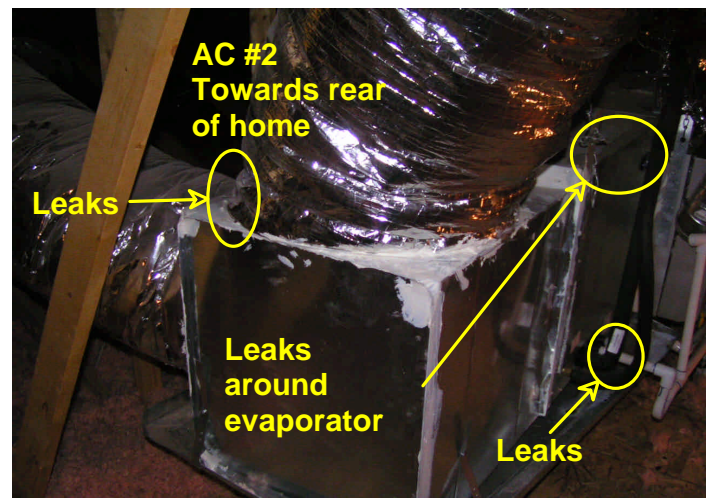
8.5 - More leaks.

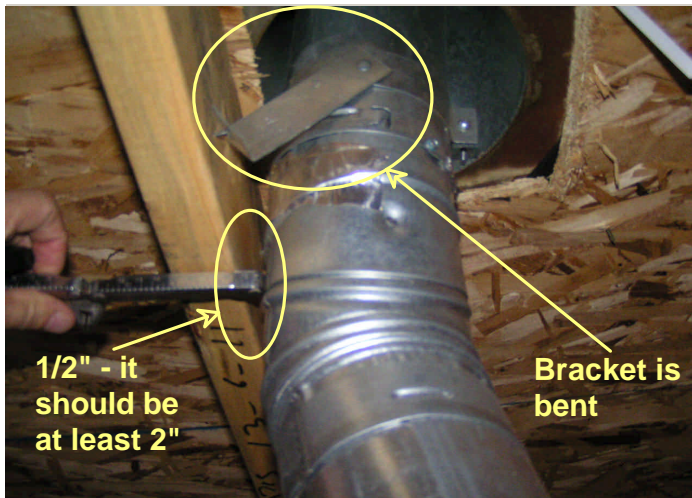
8.8 - The double-walled vent pipe should be one inch away from the roof framing, or it could create pyrophoric conditions and a fire-hazard, and should be serviced by an HVAC contractor.

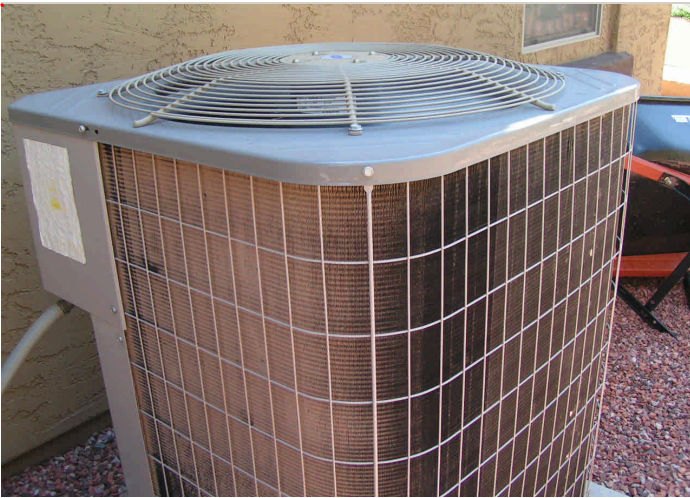
8.18 - The condensing coil is dirty and would benefit by being cleaned with a hose, then rinsed with R.O. water if possible.

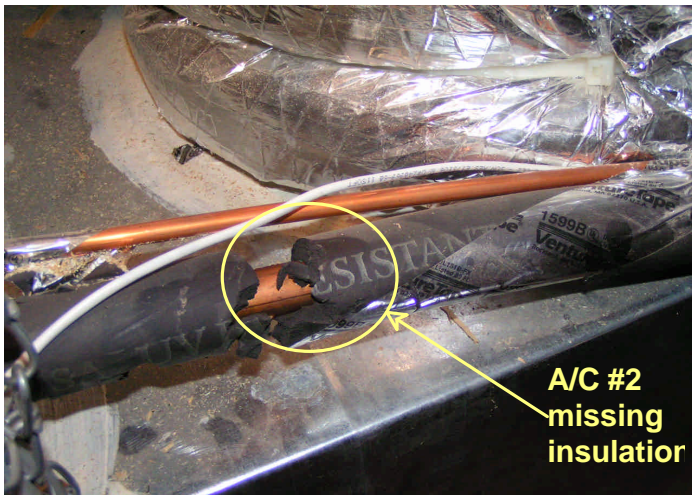
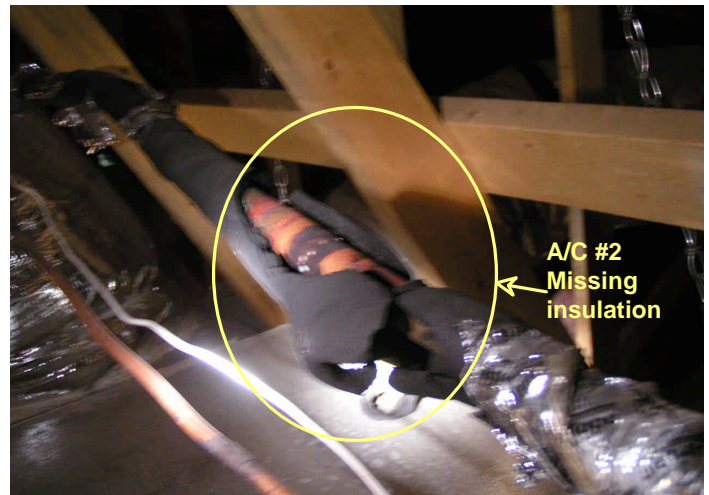
8.19 - Insulation is missing from the refrigerant lines at the evaporator coil, which will allow condensation to form and drip, and should be installed.
