CONFIDENTIAL INSPECTION REPORT Infrared Thermal Scan

5678 Harmony Lane, AZ 85396

9/17/2007 11:30 am

Electrical, HVAC, Insulation

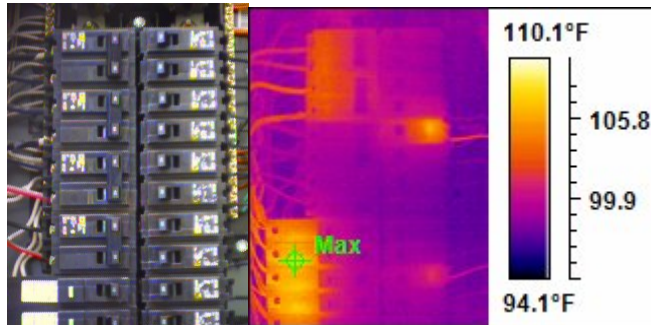
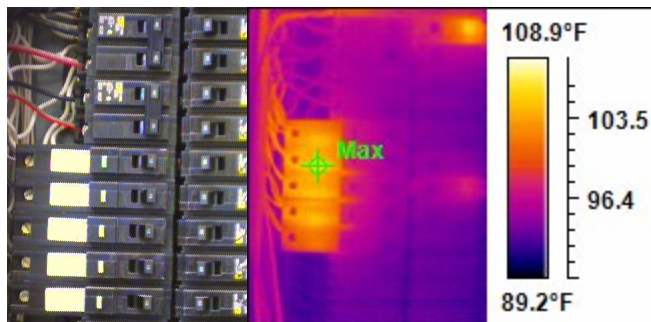
The electrical panel was scanned after the ac units had been running for 30 minutes. The temperatures are normal.

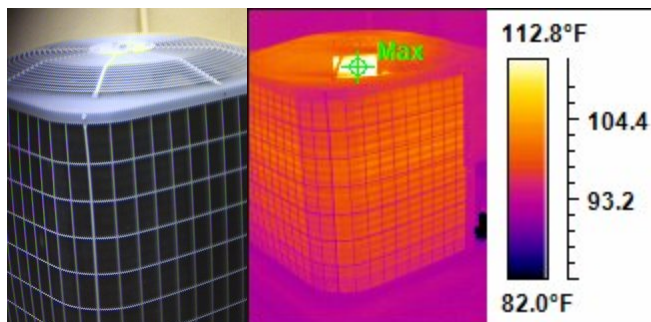
Condenser Unit #1 – The coils have even distribution and all temperatures are within acceptable limits.

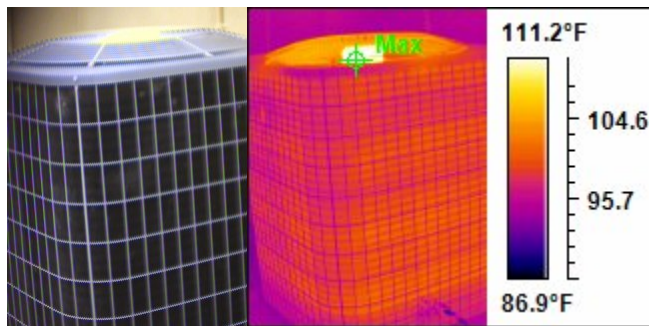
Condenser Unit #2 – The coils have even distribution and all temperatures are within acceptable limits.

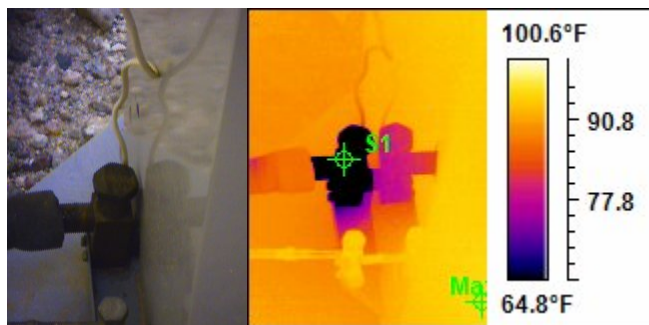
Condenser Unit #1 – Acceptable coolant differential. S1=47.8°

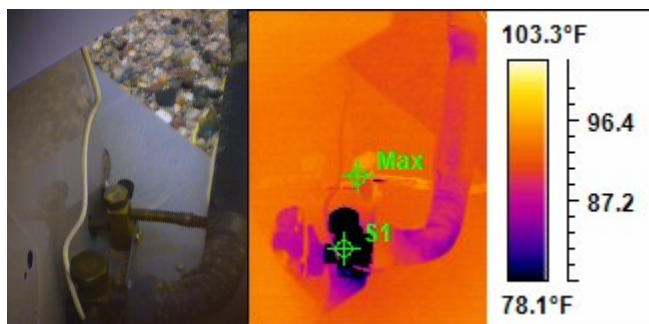
Condenser Unit #2 – Acceptable coolant differential. S1=49.6°

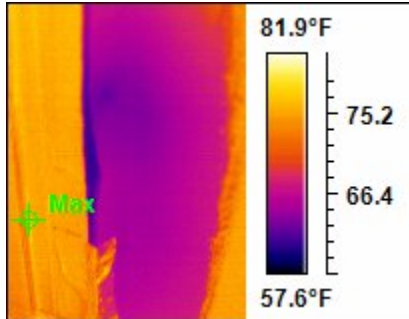
The rear air handler is leaking cold air where the access panel to the evaporator is taped. The tape has come loose. A more secure method of sealing is needed such as duct sealant. This needs evaluation and correction by a qualified professional.

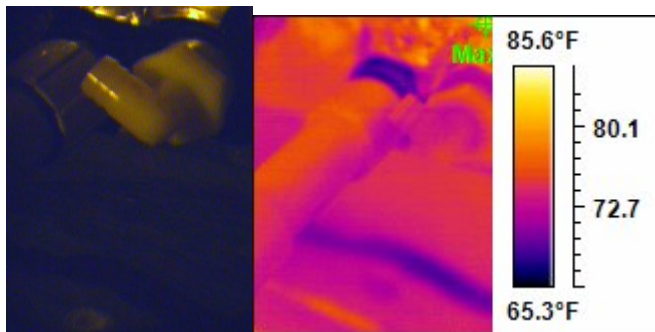
The rear air handler is leaking cold air at condensate drain and refrigerant connections. This needs evaluation and correction by a qualified professional.

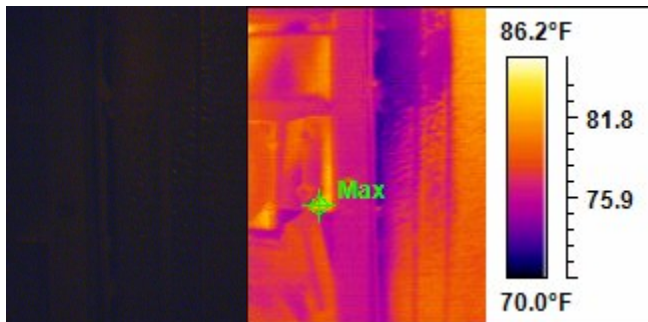
The rear air handler is blowing cold air from a moderate gap between the furnace and the evaporator cabinet. This needs evaluation and correction by a qualified professional.

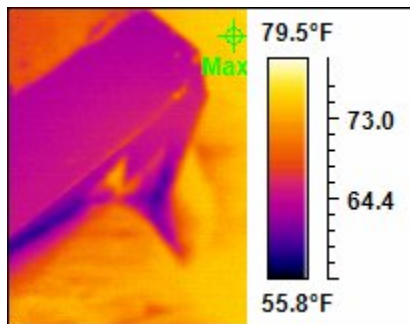
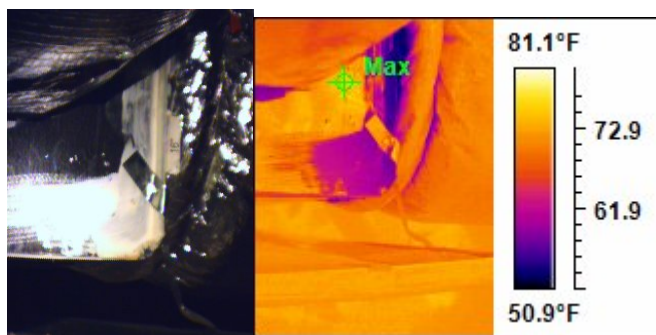
The rear air handler is leaking cold air from behind the plenum at the duct connection. Above is a view from the top. Below is a view from beneath. This needs evaluation and correction by a qualified professional.

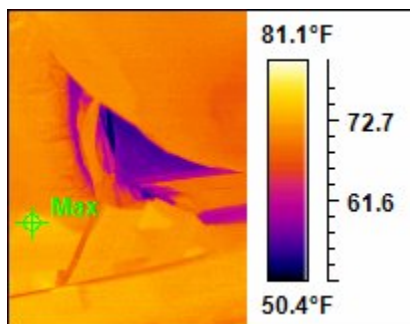
The front air handler is leaking from the supply plenum duct connection. This view is from beneath.

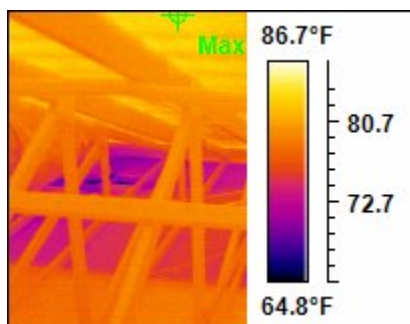
At the left center, the supply duct connection to the register to the uninsulated exercise room is atypically cold for an attic. It could be leaking cold air into the attic. This needs evaluation and correction by a qualified professional.

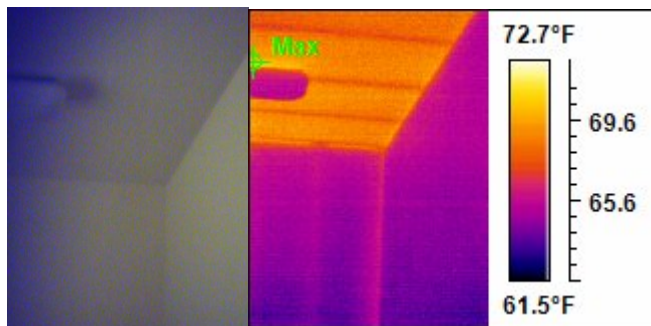
The north east corner of the exercise room shows atypical heat from the ceiling as would be the case if there were no insulation. This was confirmed visually in the attic.

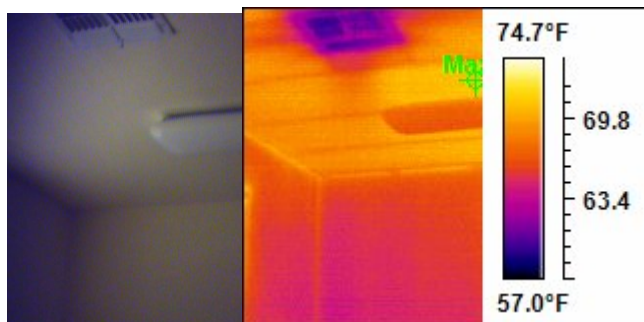
The north west corner shows the same pattern.

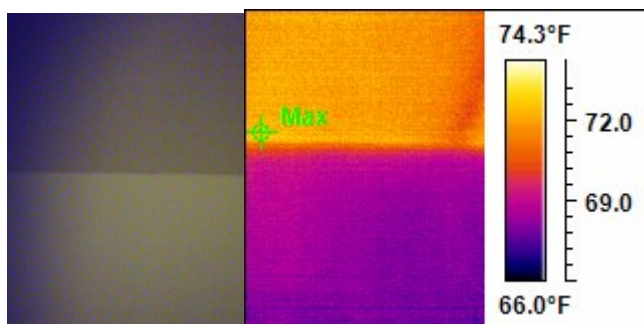
The south east wall and ceiling show the atypical heat differential between the wall and the ceiling of missing ceiling insulation.
